Technical Report CHL-97-17
August 1997

Periodic Inspection of Humboldt Bay Jetties, Eureka, California

Report 1

Base Conditions

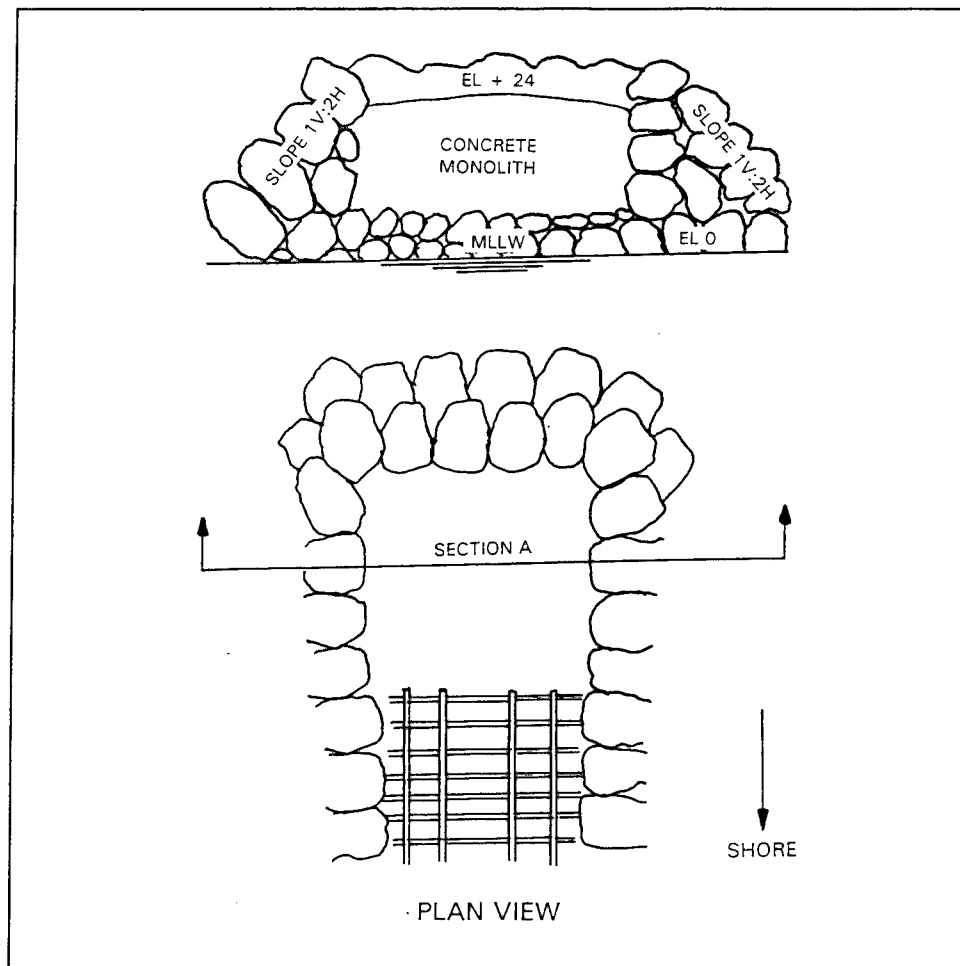
Figure 2. Concrete monolith structure constructed on south jetty in 1911

The head of the south jetty, which had been subjected to some of the most severe damage, was reinforced with a concrete monolith that was 9.1 m (30 ft) wide and 4.3 m (14 ft) deep (Figure 2). The 861,825-kg (950-ton) monolith was placed in the center of the head and armor stones up to 18,140 kg (20 tons) were laid up adjacent to the monolith. The el of the head was raised to +7.3 m (+24 ft) and the voids between the armor stones were filled with stones of not less than 227 kg (500 lb) in weight.

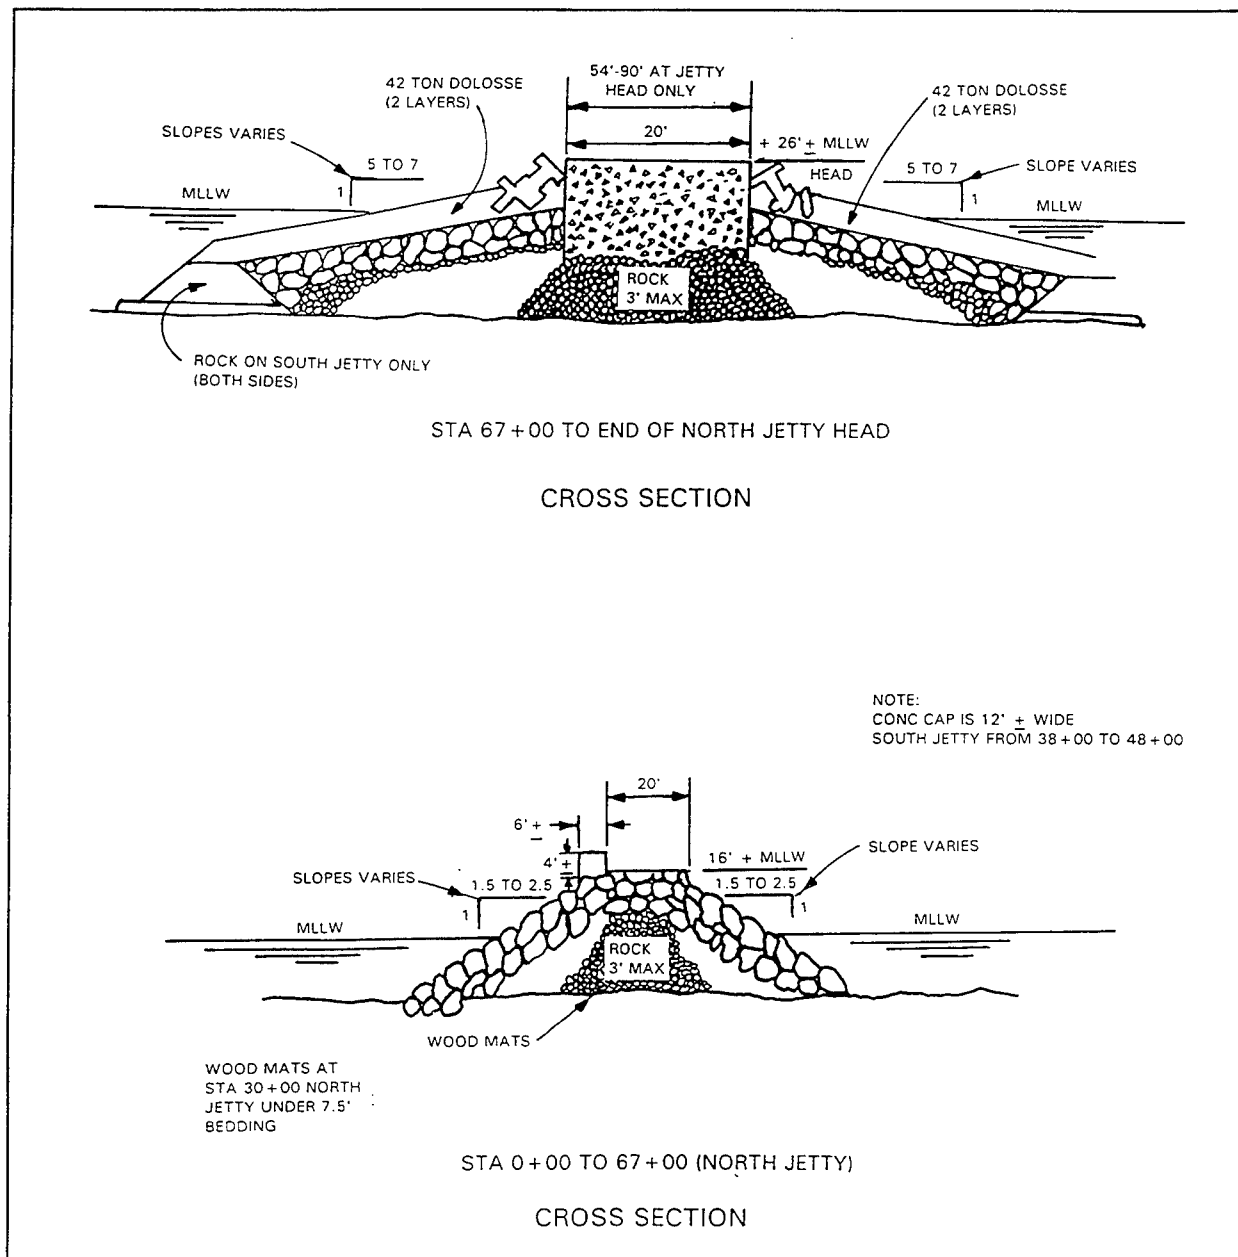
Figure 3. Typical cross section of north jetty

Following the armoring of the structure heads with dolosse, damage to the structure has been primarily along the trunk reaches of the jetties. To this point, the dolos fields appear to be performing well and no extensive repair work has been necessary on either jetty since completion of the work. Figures 3 and 4 show typical cross sections for the north and south jetties, respectively.
